FLORENCE COPPER INC.

April 22, 2019
HA File No. 132473-003

**Re: Mechanical Integrity Demonstrations, PTF Injection Wells
Production Test Facility, UIC Permit No. R9UIC-AZ3-FY11-1
Florence Copper, Florence Arizona**

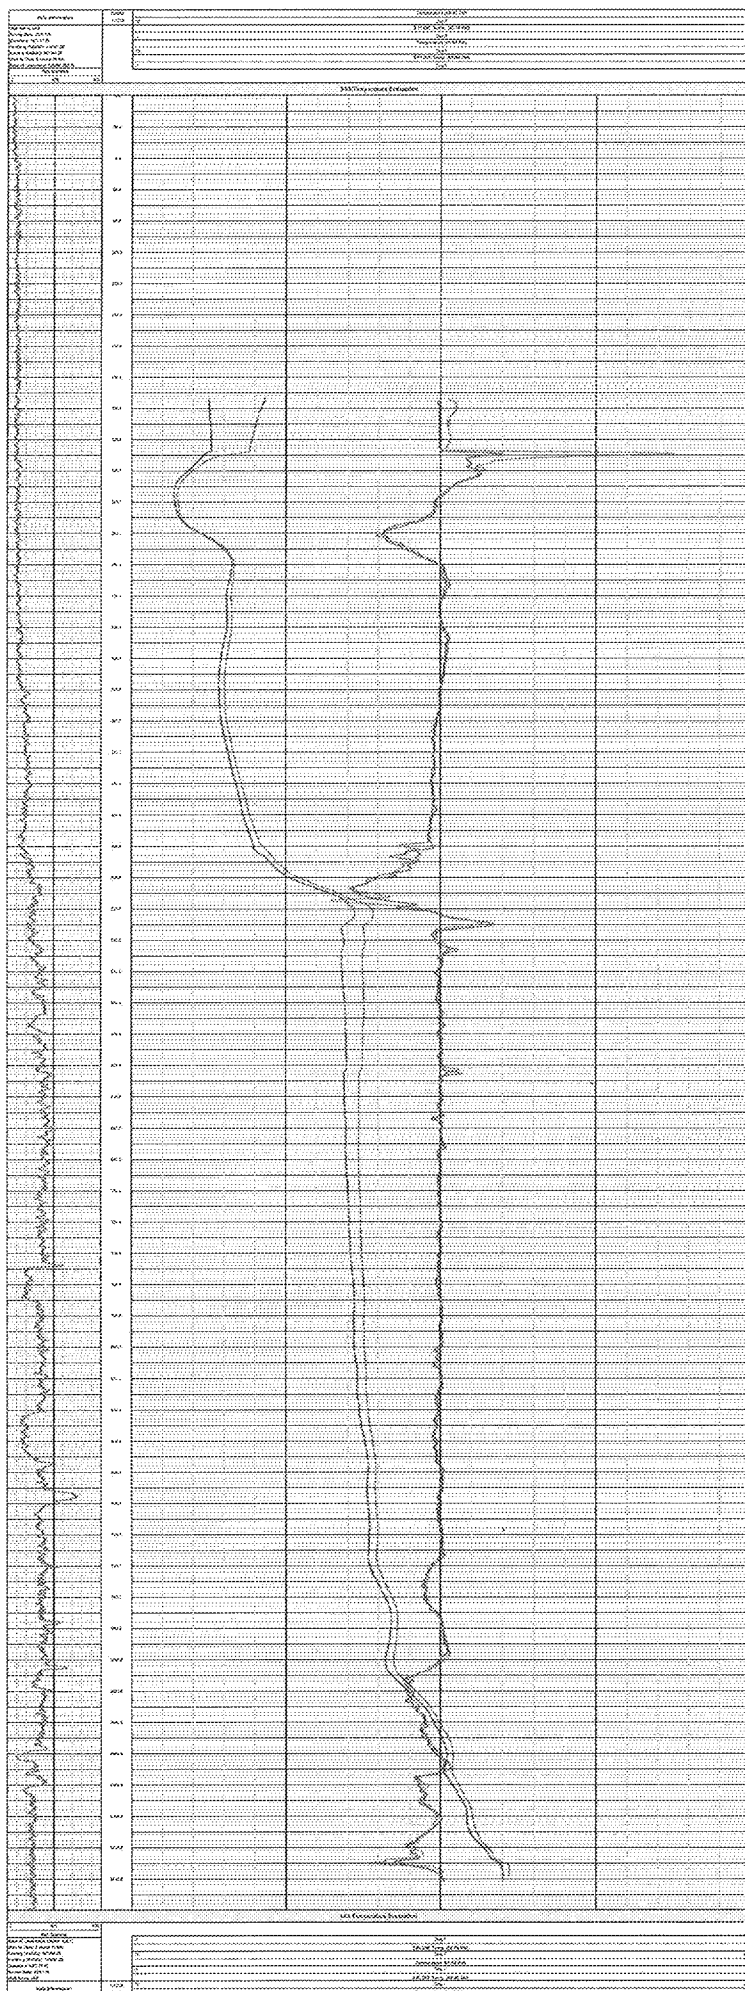
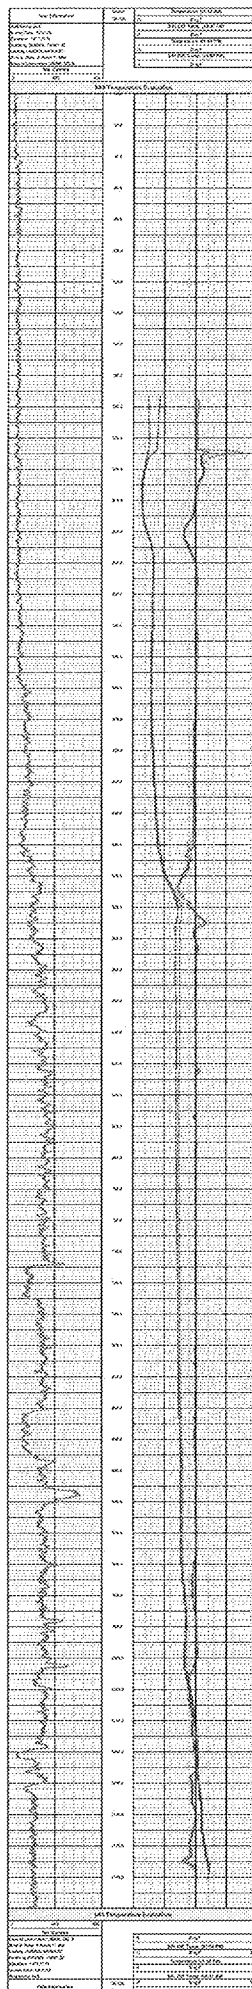
Temperature Logs

The temperature logging results for all injection wells show no anomalies that would indicate that there is flow behind the well casing. The temperature logs for each logging event are parallel to each other in the cemented zone and there is little to no differential between the two runs in each logging event.
